## An early 19<sup>th</sup> Century Satin Birch Beidermeier salon chair with caned seat, ebony stringing and turned front legs

### Contents

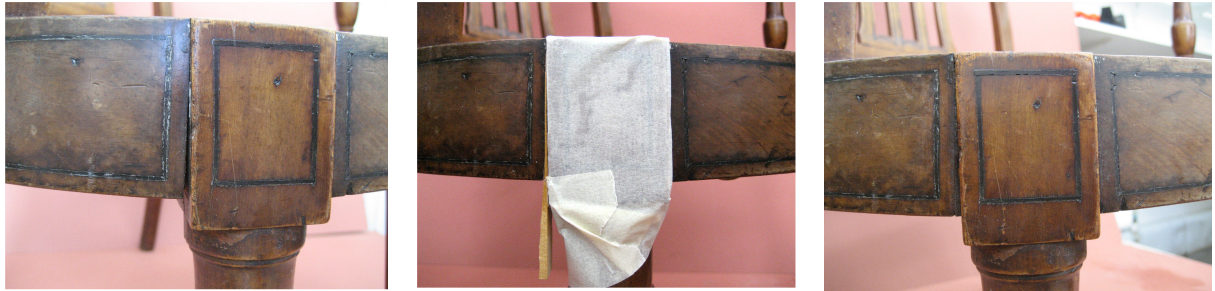
## 6. PR front leg - Consolidate Joint

There was some slight movement in the PR front leg, and a tapered gap at tenon shoulder that could not be cramped out. It was decided that the least invasive consolidation method was to insert a piece of Satin Birch carved to fit the opening. The piece was glued in with Fish Glue, using masking tape to control glue application. A final coat of shellac and earth pigment completes the blending in.

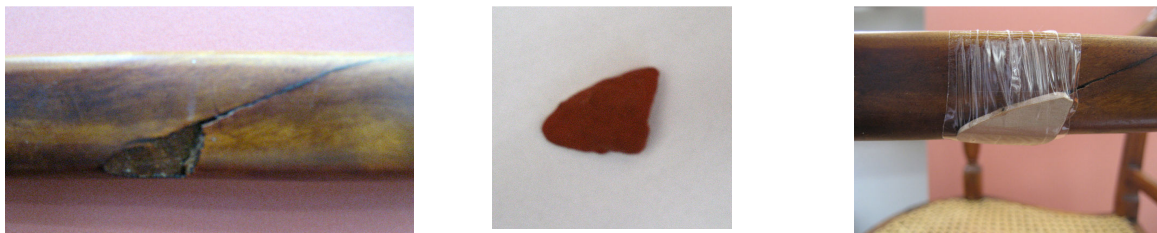
## 7. PL arm - Chip missing Decorative 1/ Item 3

There was some natural splitting in the PL arm, and a section has been lost, judging by the patination of the cleaved surface this happened some time ago. It was decided to fit a splice onto the old surface without disturbing this patination.

A piece of Plasticine® was pushed into the cavity and used as a guide for carving the inside mating surfaces of our “conservation splice”. A piece of Satin Birch was carved to this shape and glued into place using Fish Glue and cramped into place with Sellotape®

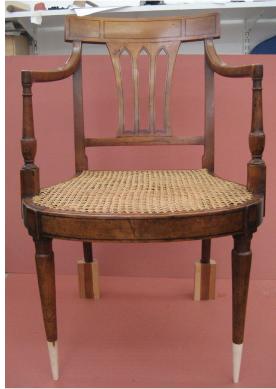
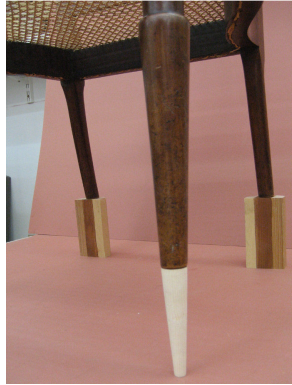
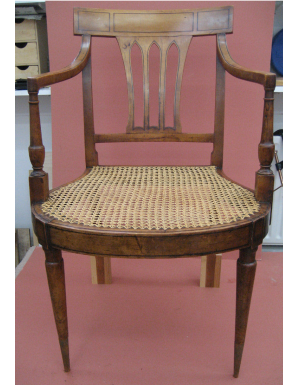
## 8. Preparation for replacing missing leg sections

The chair has been cut down at some point, and after research and measurement, sections of pine were turned to simulate how the leg would have looked if the taper had continued to the correct height. The sections were then quickly coloured in to show visually how that would have looked.

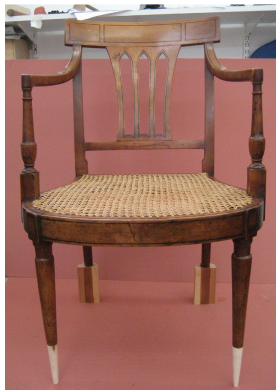
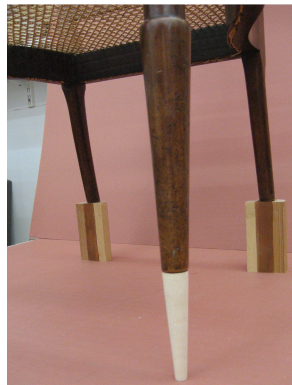
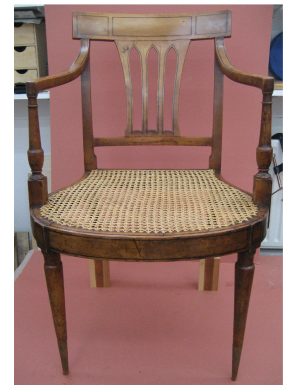
## 9. Replacing the missing leg sections

The chair has been cut down at some point, and after research and measurement, sections of pine were turned to simulate how the leg would have looked if the taper had continued to the correct height. The sections were then quickly coloured in to show visually how that would have looked had the taper continued.

Clearly this is incorrect and research will now guide the choice of replacement foot at the front – the rear legs will continue as they are simply oval in cross-section.
