CONDITION REPORT AND TREATMENT PROPOSAL

OBJECT: Late 18th Century Long case clock by Rowbotham of Leicester

TREATMENT REPORT

| OBJECT: | Late 18 th Century Long case clock by Rowbotham of Leicester | |

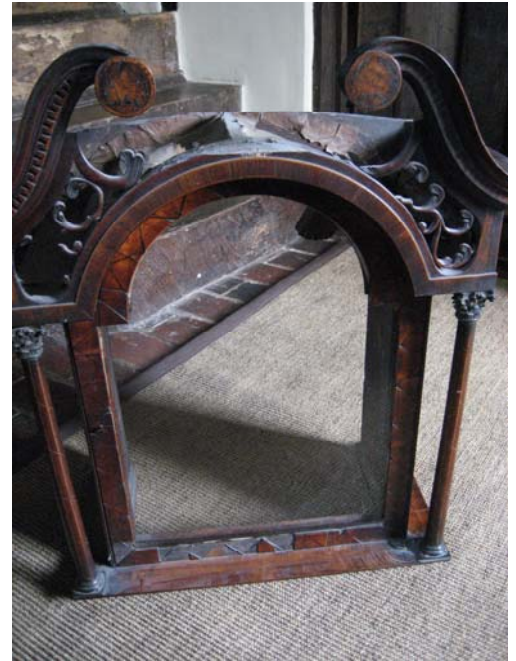
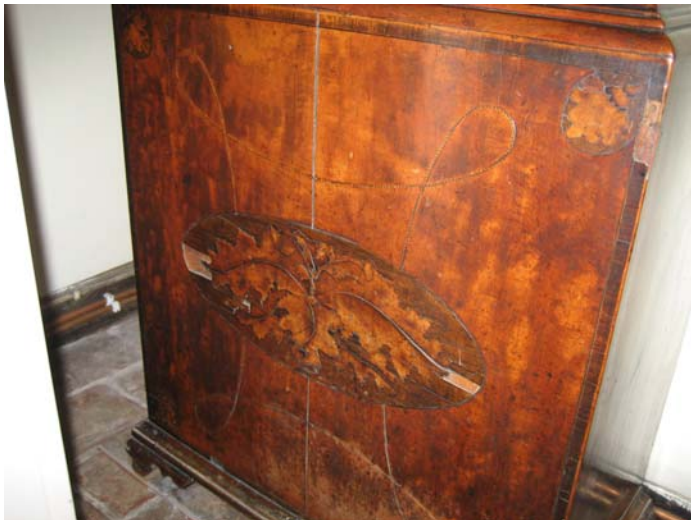
The hood is missing the central elements and all of its brass furniture except the column base and capitals. There are losses to the carving, the key ornament is 75% missing, there are around 25% losses to the satinwood and ebony veneers to the door. The paper dust cover has disintegrated and one of the side posts for supporting a ball is missing.

There is evidence of a forced entry into the weight cabinet with damaged moulding and veneer and the lock is missing.

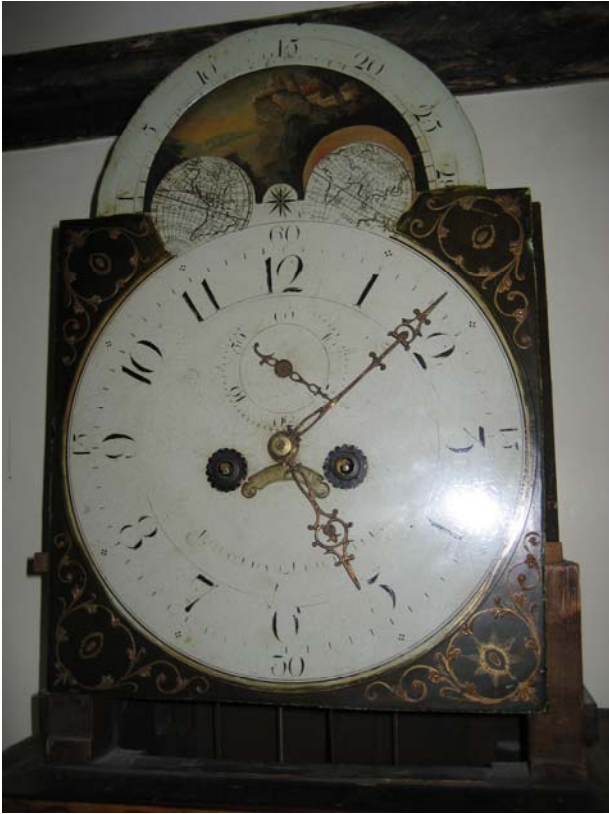
The dial has lost 90% of its applied oil gilding and has 30% of its over-painting abraded away. The makers name can just be recognised under raking light. There are accretions to the painted areas and the corner spandrels are corroded.

After a thorough clean some repainting will be necessary before re-gilding in the missing ring. The brass hands will be carefully cleaned and re-fitted.

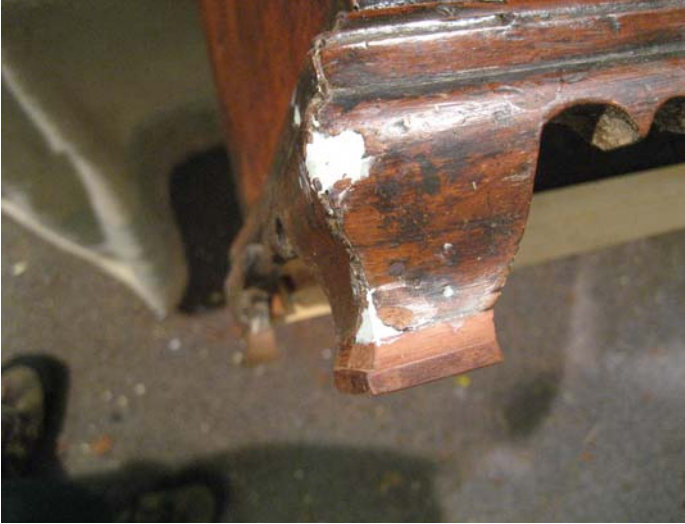
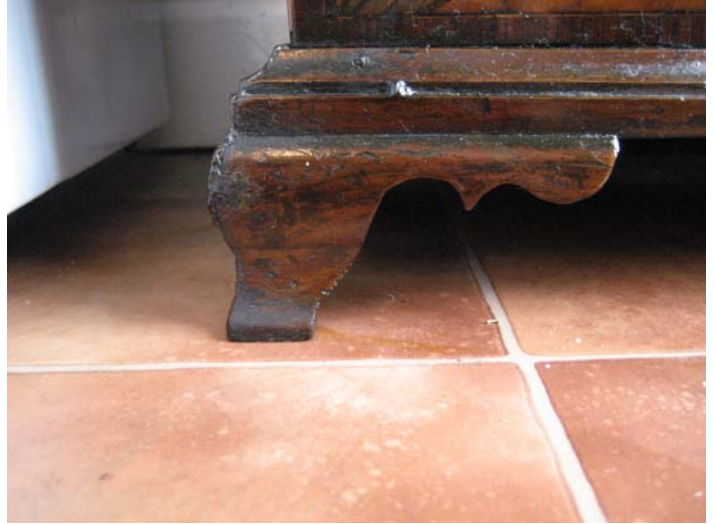
1. The ogee feet

Three out of four feet have losses and are almost entirely detached from the carcass.

The nails securing the applied strengthener timbers were carefully removed and new timber spliced into place on three of the four feet to allow subsequent levelling of the case. Voids were filled using polyester filler laid on a barrier coat of hide glue. The final colouring and finishing using water stains suspended in layers of shellac.

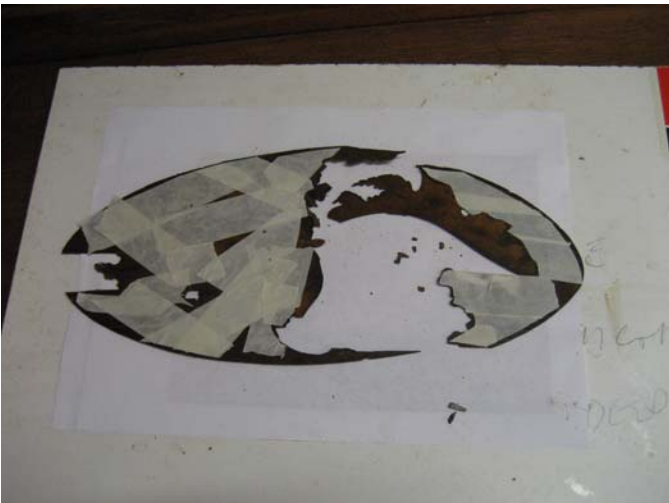
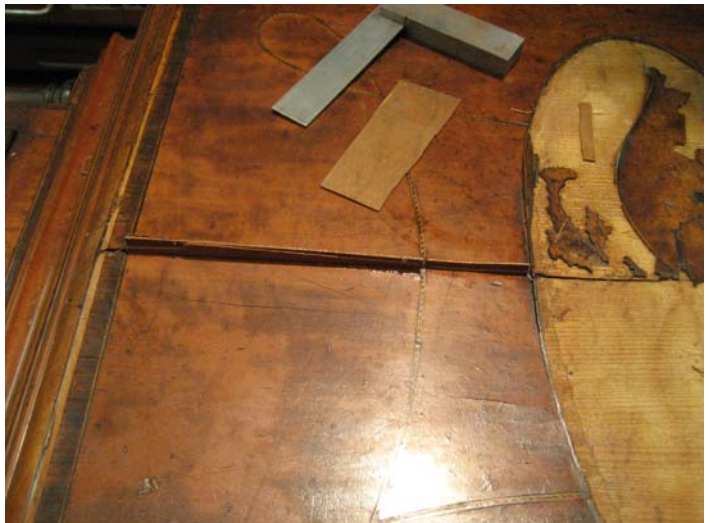
2. Lower case split

The lower marquetry panel has losses and is heavily cleaved; there is a large shrinkage split in the lower case.

The loose areas of marquetry were removed and the degraded glue removed ready for re-instatement. The split to the carcass was cleaned before satinwood veneer was used to fill the void. Cleft pine was used under the medallion and under the crossbanding.

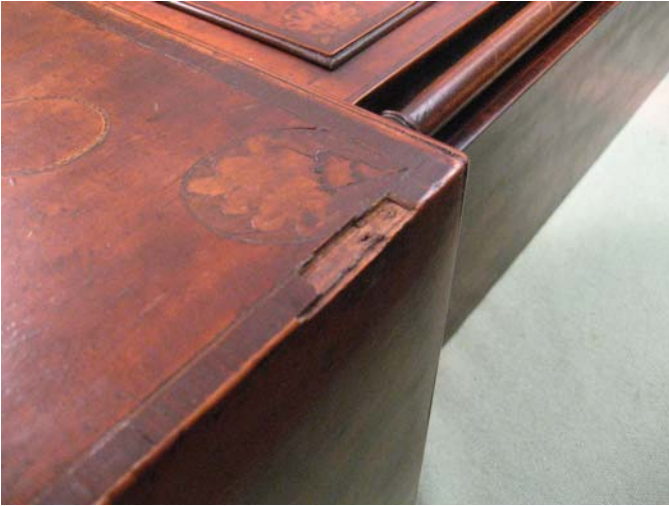
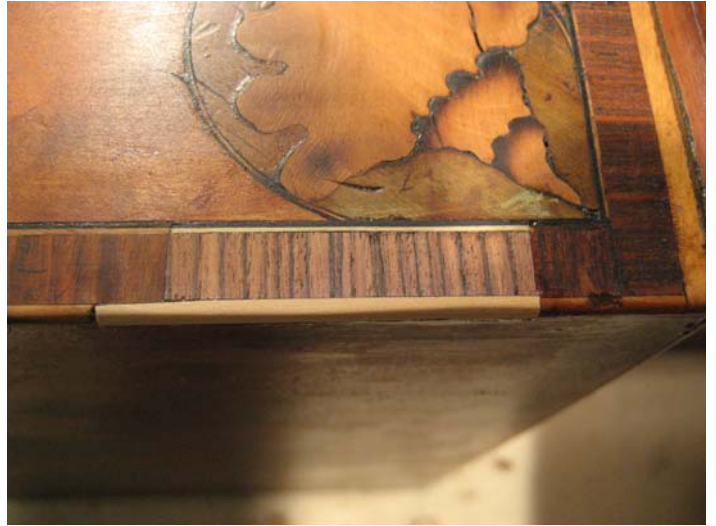
3. Replacing missing crossbanding

There are losses to the tulipwood ebony and boxwood bandings and some losses to the tulipwood ebony and hare-wood bandings.

The unsightly discoloured polish was removed before each area of missing crossbanding and boxwood stringing was custom made a fitted. Each section was glued with hide glue then levelled and fitted.

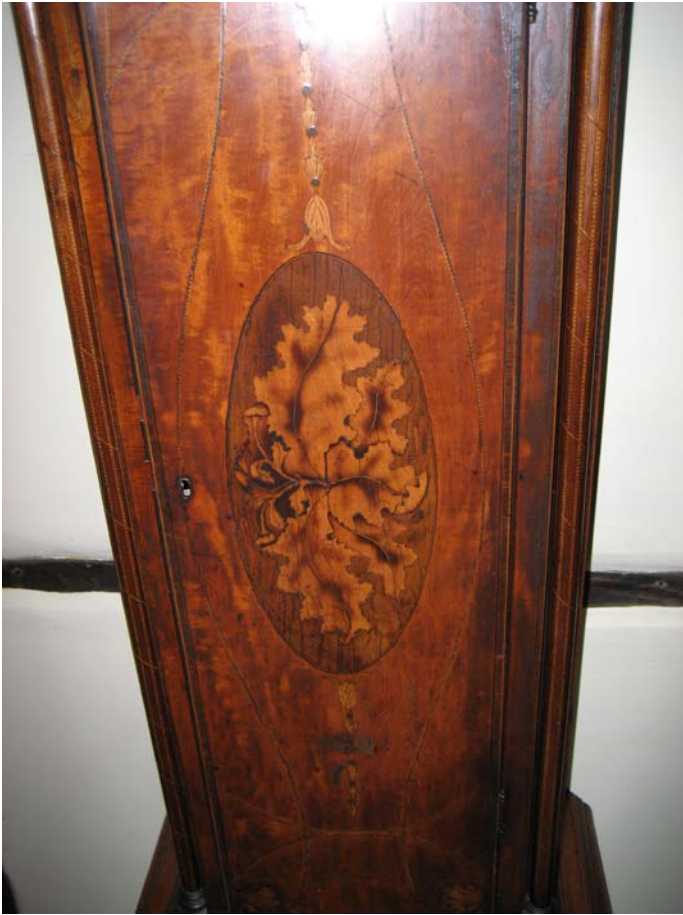
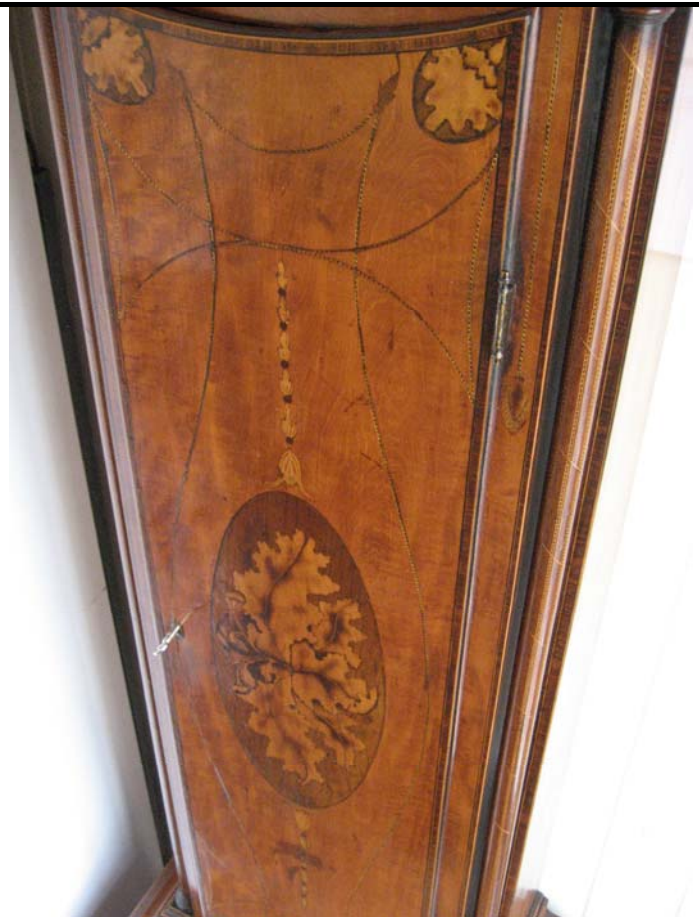
10. The Surface

The entire surface is accreted with deposits and the polished finish is badly degraded leaving much of the decorative veneer work obscured.

The entire finish was cleaned using de-ionised water and white spirits to remove accretions before careful cutting back of degraded polish using IMS and isopropyl alcohol to remove successive layers until fractured and discoloured polish no longer obscured design details at 6 feet viewing distance.
