CONDITION REPORT AND TREATMENT PROPOSAL

OBJECT: Late 18th Century Long case clock by Rowbotham of Leicester

TREATMENT REPORT

| OBJECT: | Late 18 th Century Long case clock by Rowbotham of Leicester | |

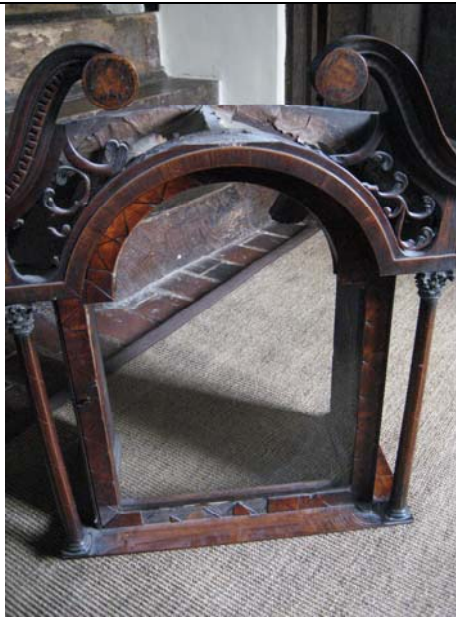
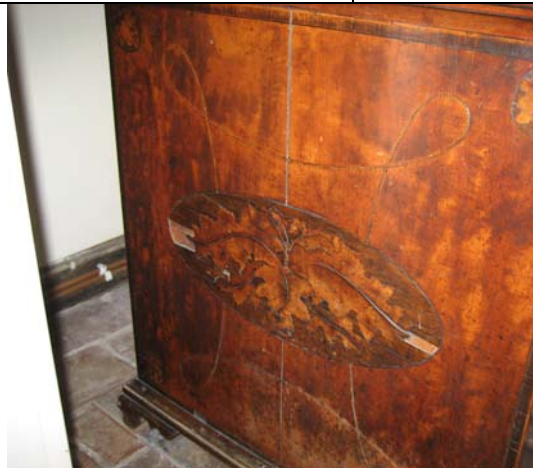
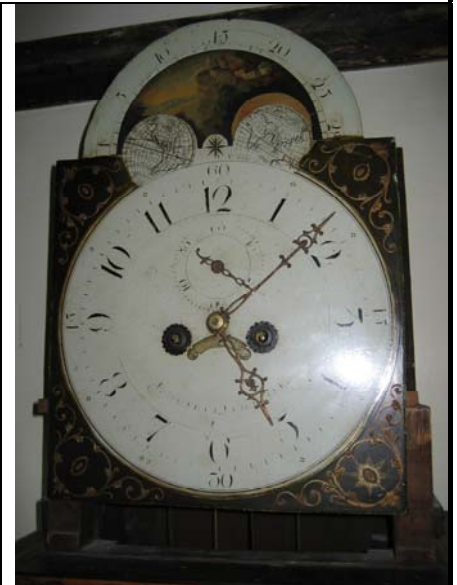
Late 18th Century Long case clock by Rowbotham of Leicester.

The pine carcass is veneered with East Indian Satinwood with marquetry panels of boxwood and walnut, ebony and boxwood stringing, and tulipwood ebony and hare-wood bandings alongside tulipwood ebony and boxwood bandings. The mahogany feet are later, the brass furniture from the hood is all missing, and the door is missing its lock but otherwise the case is in original condition.
